PAVEMENT MANAGEMENT PLAN

Prepared For:
The Village of Jerome

May 2014

K U H N & T R E L L O

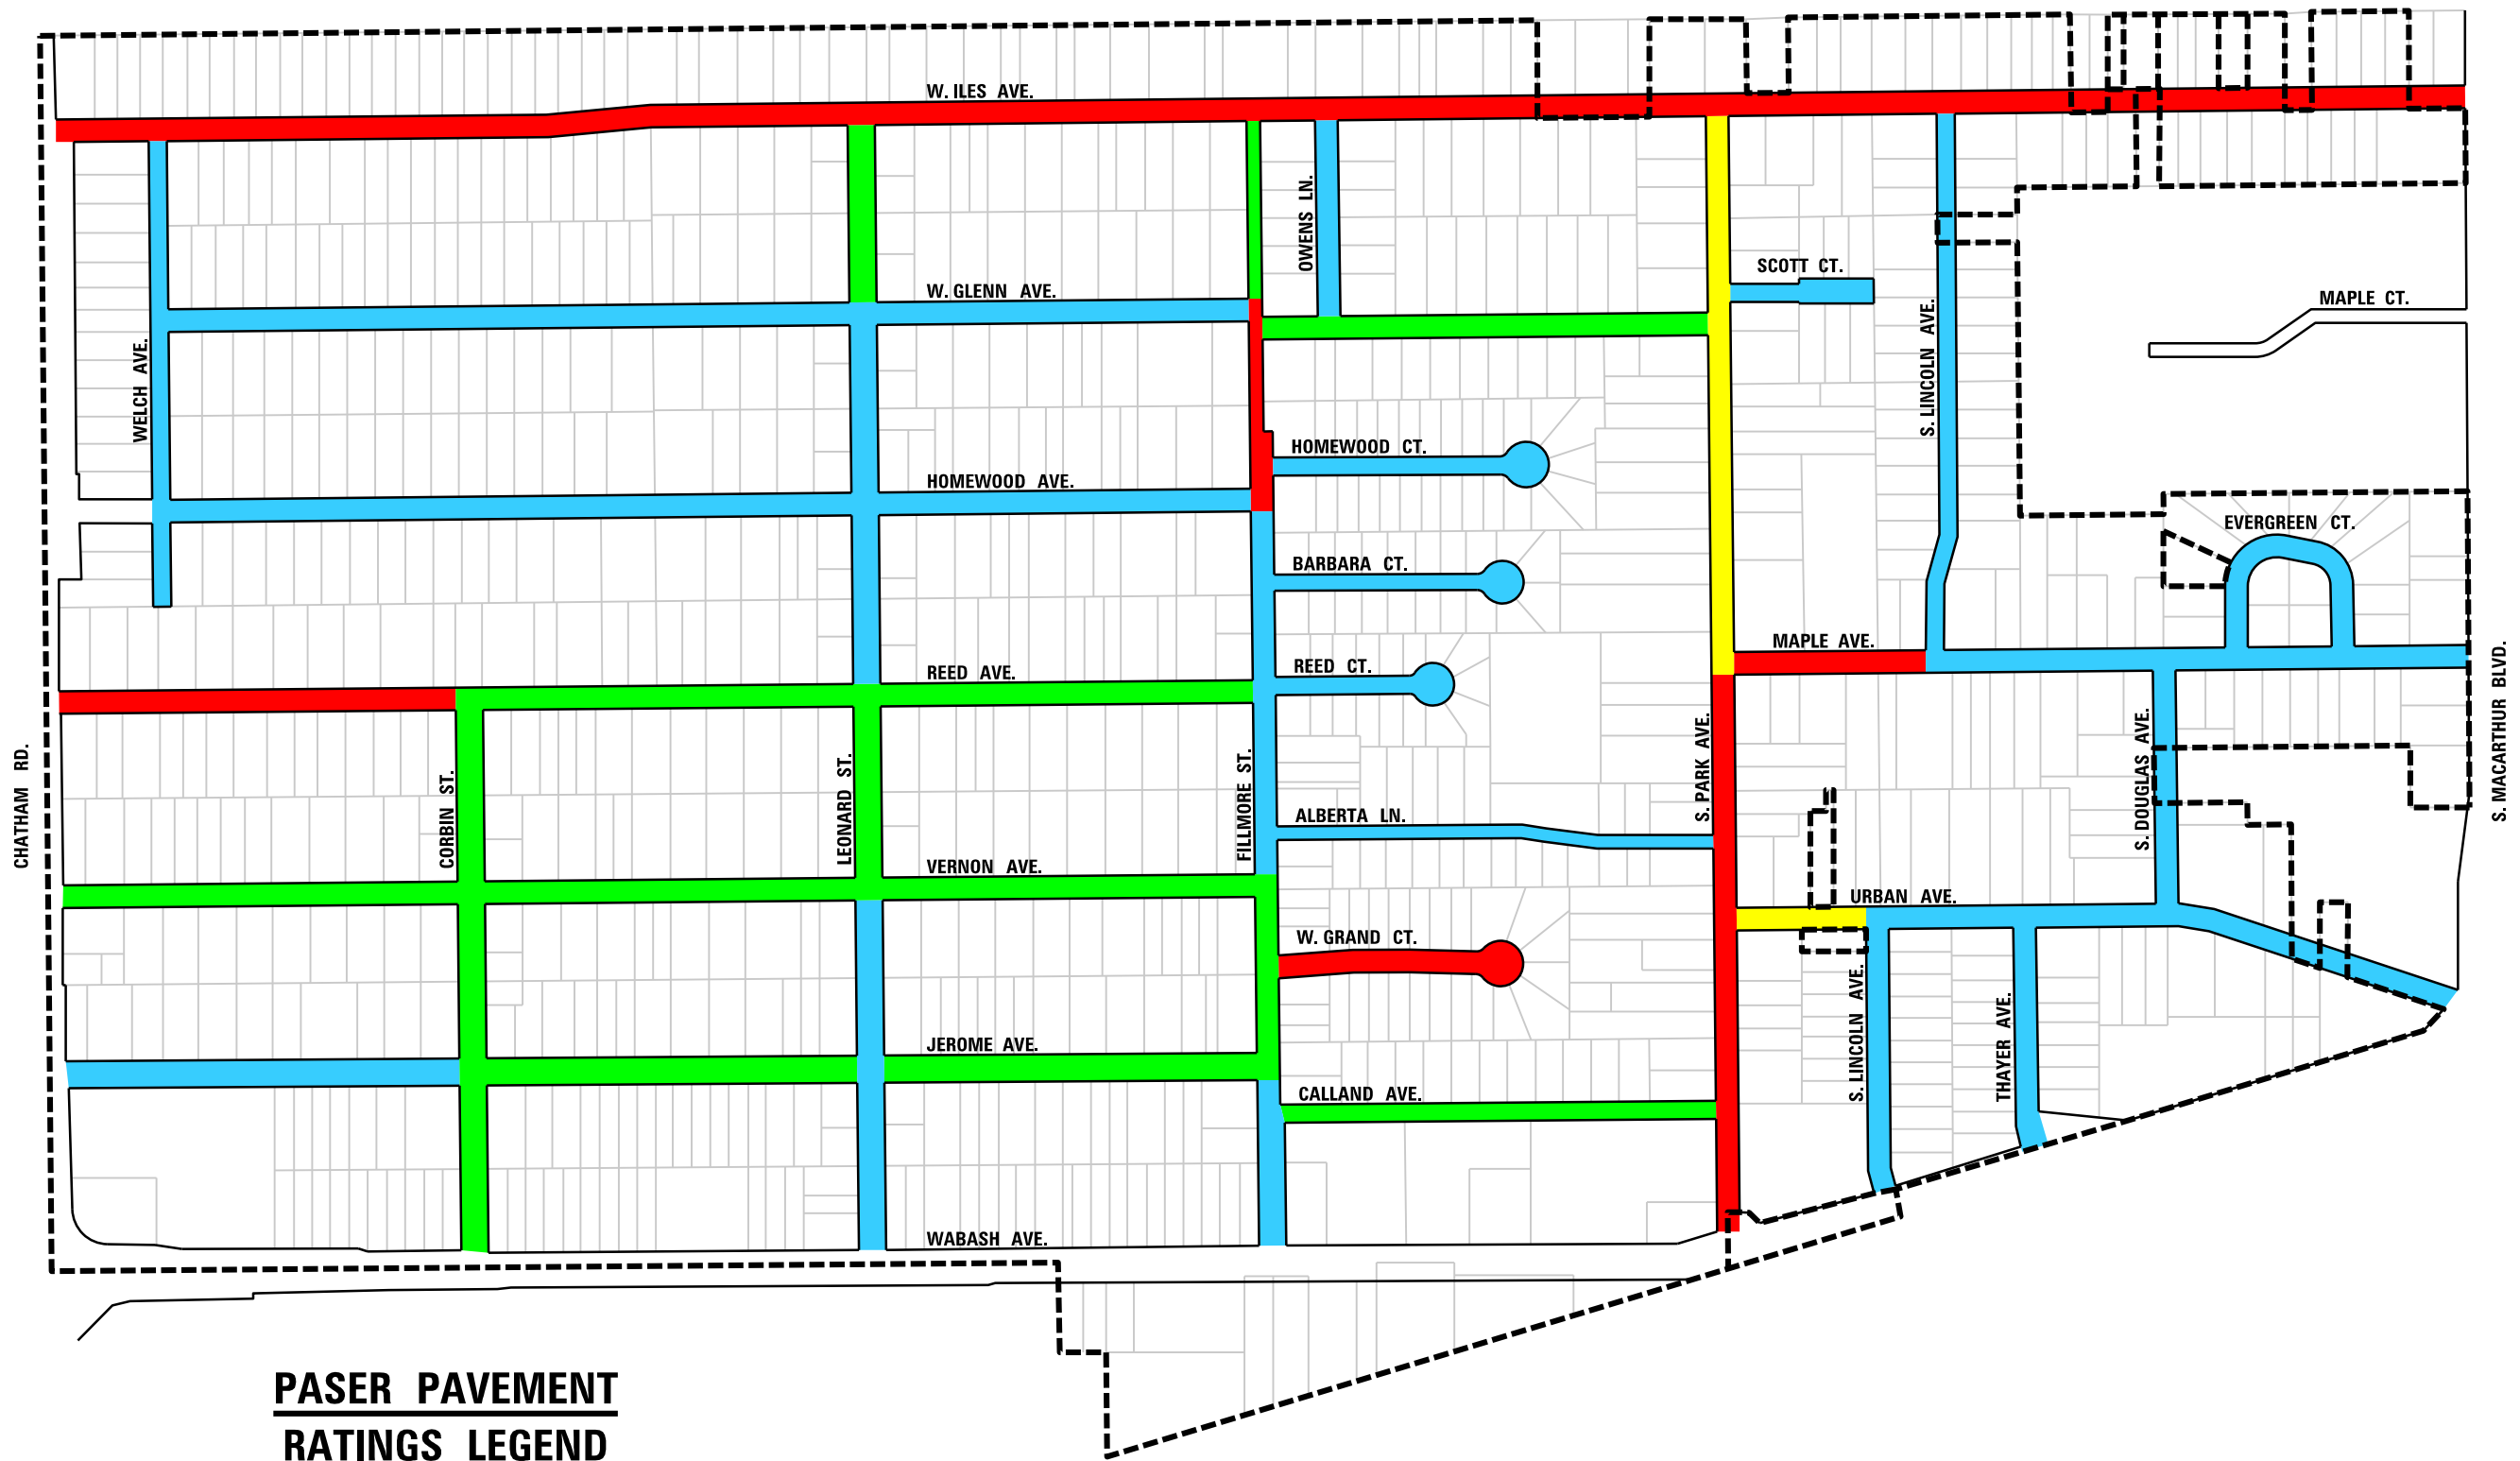
PASER PAVEMENT RATINGS LEGEND

Street	From	To	Length (FT)	Width (FT)	2014 PASER Rating	Notable Distresses	Maintenance Measure
WELCH AVE.	HOMWOOD AVE.	W GLENN AVE.	410	24	8	None	-
WELCH AVE.	W GLENN AVE.	W ILES AVE.	415	24	8	None	-
OWENS LN.	W GLENN AVE.	W ILES AVE.	470	24	8	None	-
S LINCOLN AVE.	WABASH AVE.	URBAN AVE.	590	31	8	None	-
THAYER AVE.	WABASH AVE.	URBAN AVE.	530	30	8	None	-
S DOUGLAS AVE.	URBAN AVE.	MAPLE AVE.	560	24	8	None	-
HOMWOOD CT.			610	24	8	None	-
HOMWOOD AVE.	LEONARD ST.	FILLMORE ST.	840	26	8	None	-
BARBARA CT.			550	24	8	None	-
REED CT.			400	24	8	None	-
EVERGREEN CT.			640	21	8	None	-
URBAN AVE.	THAYER AVE.	DEAD END	930	22	8	None	-
WELCH AVE.	DEAD END	HOMWOOD AVE.	185	24	7	Longitudinal, Raveling	Seal Coat
LEONARD ST.	WABASH AVE.	JEROME AVE.	400	26	7	Longitudinal, Raveling	Crack Filling & Seal Coat
LEONARD ST.	JEROME AVE.	VERNON AVE.	385	26	7	Longitudinal, Raveling	Crack Filling & Seal Coat
LEONARD ST.	REED AVE.	HOMWOOD AVE.	415	26	7	Longitudinal, Raveling	Crack Filling & Seal Coat

LEONARD ST.	HOMWOOD AVE.	W GLENN AVE.	415	26	7	Longitudinal, Raveling	Crack Filling & Seal Coat
FILLMORE ST.	WABASH AVE.	JEROME AVE.	400	24	7	Longitudinal, Transverse, Raveling	Crack Filling & Seal Coat
FILLMORE ST.	VERNON AVE.	REED AVE.	420	24	7	Longitudinal, Transverse, Raveling	Crack Filling & Seal Coat
FILLMORE ST.	REED AVE.	HOMWOOD AVE.	415	24	7	Longitudinal, Transverse, Raveling	Crack Filling & Seal Coat
S LINCOLN AVE.	MAPLE AVE.	W ILES AVE.	1200	22	7	Transverse, Edge	Crack Filling & Seal Coat
W GLENN AVE.	WELCH AVE.	LEONARD ST.	1520	26	7	Longitudinal	Crack Filling & Seal Coat
W GLENN AVE.	LEONARD ST.	FILLMORE ST.	840	26	7	Longitudinal	Crack Filling & Seal Coat
SCOTT CT			315	22.5	7	Longitudinal	Crack Filling & Seal Coat
HOMWOOD AVE.	WELCH AVE.	LEONARD ST.	1520	26	7	Longitudinal, Transverse	Crack Filling & Seal Coat
MAPLE AVE.	S LINCOLN AVE.	S DOUGLAS AVE.	500	22	7	Longitudinal, Transverse	Crack Filling & Seal Coat

MAPLE AVE.	S DOUGLAS AVE.	S MACARTHUR BLVD.	660	22	7	Longitudinal, Transverse	Crack Filling & Seal Coat
ALBERTA LN.	FILLMORE ST.	S PARK AVE.	990	24	7	Longitudinal, Transverse, Rutting (Minor)	Crack Filling & Seal Coat
URBAN AVE.	S LINCOLN AVE.	THAYER AVE.	325	22	7	Transverse	Crack Filling & Seal Coat
JEROME AVE.	CHATHAM RD.	CORBIN ST.	900	26	7	Longitudinal, Transverse	Crack Filling & Seal Coat
CORBIN ST.	WABASH AVE.	JEROME AVE.	400	22	6	Longitudinal, Transverse, D-Block, Raveling	Crack Filling & Seal Coat
CORBIN ST.	JEROME AVE.	VERNON AVE.	385	22	6	Longitudinal, Transverse, D-Block	Crack Filling & Seal Coat
CORBIN ST.	VERNON AVE.	REED AVE.	425	22	6	Longitudinal, Transverse, D-Block	Crack Filling & Seal Coat
LEONARD ST.	VERNON AVE.	REED AVE.	420	26	6	Potholes, Patching in poor condition	Patching & Seal Coat
LEONARD ST.	W GLENN AVE.	W ILES AVE.	435	26	6	Potholes, Raveling	Patching & Seal Coat
FILLMORE ST.	JEROME AVE.	VERNON AVE.	385	24	6	Longitudinal, Transverse, Raveling	Crack Filling & Seal Coat

VERNON AVE.	CORBIN ST.	LEONARD ST.	860	25	6	CL Patch settled, sealed	Patching & Seal Coat
VERNON AVE.	LEONARD ST.	FILLMORE ST.	840	20	6	CL Patch settled, sealed, Transverse	Patching & Seal Coat
JEROME AVE.	CORBIN ST.	LEONARD ST.	860	26	6	Longitudinal, Transverse	Crack Filling & Seal Coat
JEROME AVE.	LEONARD ST.	FILLMORE ST.	840	26	6	Transverse, Patch settling	Patching & Seal Coat
CALLAND AVE.	FILLMORE ST.	S PARK AVE.	990	27	6	Longitudinal, Transverse, D-Block, Raveling, sealed	Crack Filling & Seal Coat
FILLMORE ST.	W GLENN AVE.	W ILES AVE.	435	19	5	Potholes, Raveling	Patching, Mill & Overlay
REED AVE.	CORBIN ST.	LEONARD ST.	860	24	5	CL Patch settled, Transverse, Raveling, Potholes	Patching & Seal Coat
REED AVE.	LEONARD ST.	FILLMORE ST.	840	20	5	CL Patch settled, Transverse, Raveling, Potholes	Patching & Seal Coat
VERNON AVE.	CHATHAM RD.	CORBIN ST.	900	22	5	Longitudinal, Transverse, D-Block	Crack Filling & Seal Coat

FILLMORE ST.	HOMWOOD AVE.	W GLENN AVE.	415	21	4	Potholes, Raveling	Patching, Mill & Overlay
W ILES AVE	LEONARD ST.	FILLMORE ST.	840	22	4	Longitudinal, Potholes, Raveling	Patching, Mill & Overlay

Street	From	To	Length (FT)	Width (FT)	2014 PASER Rating	Notable Distresses	Maintenance Measure
REED AVE.	CHATHAM RD.	CORBIN ST.	900	24	4	Longitudinal, Patching (Bad)	Patching, Mill & Overlay
S PARK AVE.	WABASH AVE.	GALLAND AVE.	275	22	3	Potholes, Transverse	Patching, Mill & Overlay
S PARK AVE.	GALLAND AVE.	ALBERTA LN.	415	22	3	Potholes, Transverse	Patching, Mill & Overlay
S PARK AVE.	ALBERTA LN.	MAPLE AVE.	550	22	3	Potholes, Transverse	Patching, Mill & Overlay
WILES AVE	CHATHAM RD.	WELCH AVE.	240	40 - 24	3	Longitudinal, Transverse, Potholes, Raveling, Rutting	Patching, Mill & Overlay
WILES AVE	WELCH AVE.	LEONARD ST.	1530	22	3	Longitudinal, Transverse, Potholes, Raveling, Rutting	Patching, Mill & Overlay
WILES AVE	FILLMORE ST.	S PARK AVE.	990	22	3	Transverse, Edge, Potholes, D-Block, Patching, Raveling	Patching, Mill & Overlay
WILES AVE	S PARK AVE.	S LINCOLN AVE.	485	22	3	Transverse, Edge, Potholes, D-Block, Patching, Raveling	Patching, Mill & Overlay

WILES AVE	S LINCOLN AVE.	S MACARTHUR BLVD.	1230	22	3	Transverse, Edge, Potholes	Patching, Mill & Overlay
W GLENN AVE.	FILLMORE ST.	S PARK AVE.	995	22	3	Longitudinal, Transverse, Edge, Potholes	Patching, Mill & Overlay
MAPLE AVE.	S PARK AVE.	S LINCOLN AVE.	460	21	3	Longitudinal, Patching, Potholes	Patching, Mill & Overlay
W GRAND CT.			535	25	3	Transverse, Potholes	Patching, Mill & Overlay
S PARK AVE.	MAPLE AVE.	W GLENN AVE.	725	22	2	Potholes, Transverse	Reconstruction
S PARK AVE.	W GLENN AVE.	WILES AVE	475	22	2	Potholes, Transverse	Reconstruction
URBAN AVE.	S PARK AVE.	S LINCOLN AVE.	320	22 - 20	2	Longitudinal, Transverse, D-Block, Potholes (first 100')	Reconstruction (First 100')
TOTAL MILES					7.58
